**Flood Control Project Maintenance  
Levee Inspections**

**Fall 2018 Levee Maintenance Deficiency Summary Report**

**Sacramento River Basin**

**Flood Control Project Maintenance  
Levee Inspections****LMA District Cover Sheet****Fall 2018 Levee Inspection Results****Sutter Maintenance Yard Wadsworth Canal**

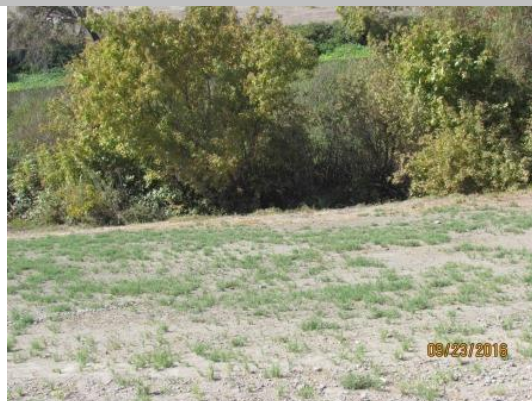
Photo 1 of 1 : FA\_2018\_ST0010\_42\_20\_20180905\_00013.jpg

View of the erosion along the waterside toe.

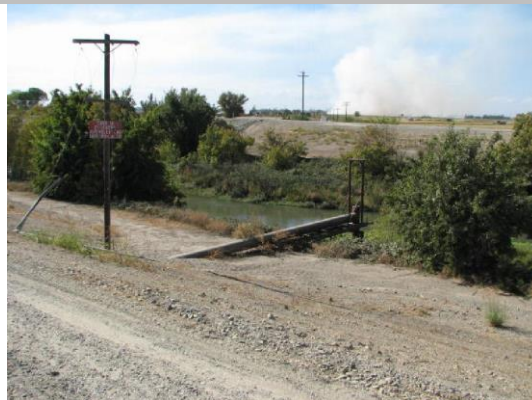
Photo 1 of 3 : UCIP\_FA\_2018\_51493\_64702.jpg

Power pole with cut powerlines, pump missing from steel pier.

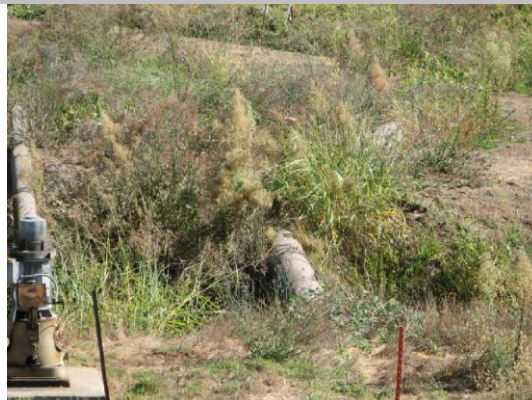
Photo 2 of 3 : UCIP\_FA\_2018\_51493\_64701.jpg

Pipe on LS toe.

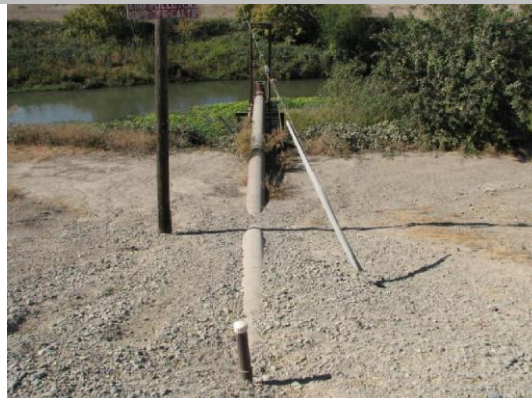
Photo 3 of 3 : UCIP\_FA\_2018\_51493\_64700.jpg

Pipe on WS slope with siphon breaker at WS shoulder.

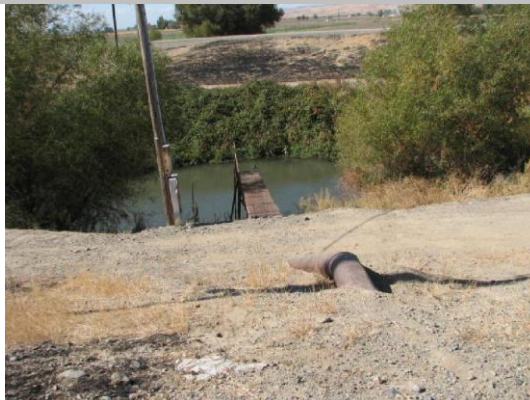
Photo 1 of 3 : UCIP\_FA\_2018\_51498\_64711.jpg

Pump missing from steel pier on WS toe.

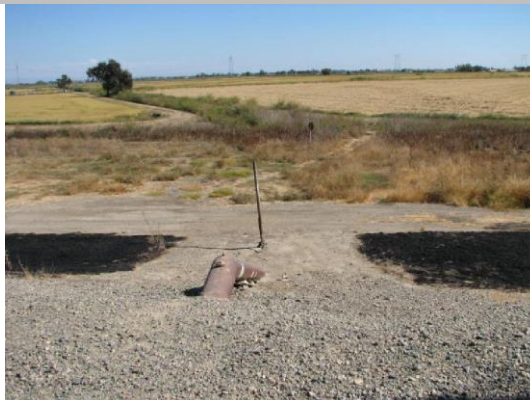
Photo 2 of 3 : UCIP\_FA\_2018\_51498\_64710.jpg

Pipe with siphon breaker plugged on LS shoulder.

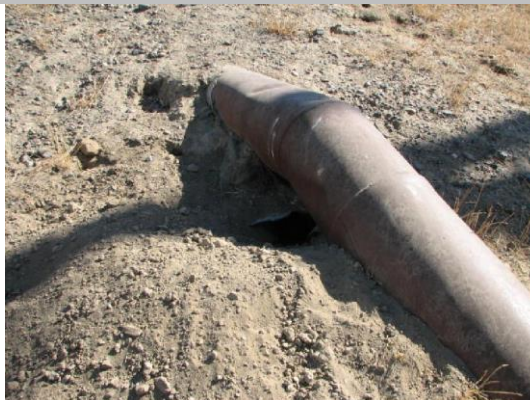
Photo 3 of 3 : UCIP\_FA\_2018\_51498\_64709.jpg

Extensive burrowing along pipe alignment on WS slope.

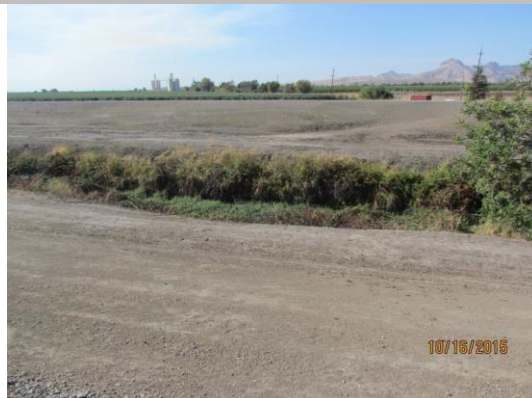
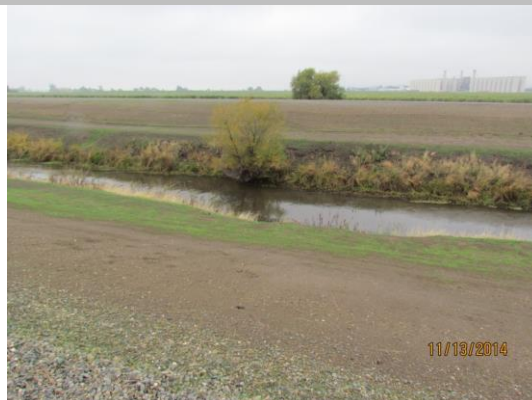
LM Start	2.43	Rating **	M	Issue No.	6
LM End	3.30	Issue Type +	Ma	Location *	WS
Category	Supplemental			GPS Latitude/Longitude	
				Start	End
Item	2017 USACE Erosion Survey, DRAFT			39.142235 °	39.153095 °
				-121.742609 °	-121.734390 °
DWR ID	DWR_ST0010_01_f_2018_6				
Comment Code					
Inspector Comment					
2017 Site ID: WAC 2.4 L					
Status: Eroding					
2017 Field Notes: Significant new erosion along lower bank.					
Site History: 2010 - Over steepened levees, some slumping, reach-wide problem. 2011 - Still a reach-wide problem.

View of the erosion along the waterside toe.

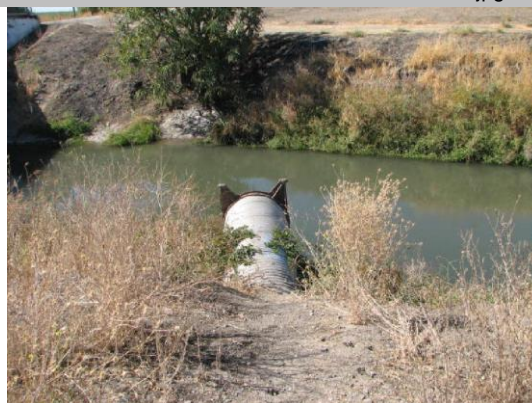
Photo 1 of 3 : UCIP\_FA\_2018\_51500\_64718.jpg

36-inch pipe with flapgate on WS slope.

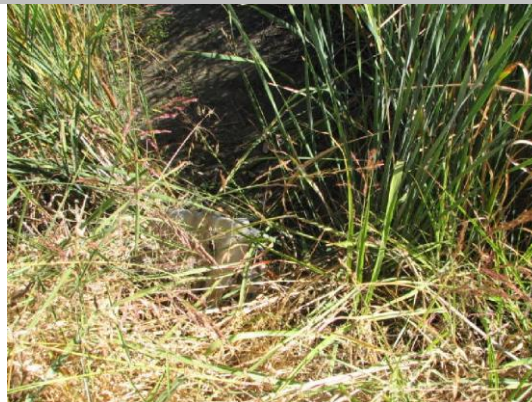
Photo 2 of 3 : UCIP\_FA\_2018\_51500\_64717.jpg

Inlet in weeds on LS toe.

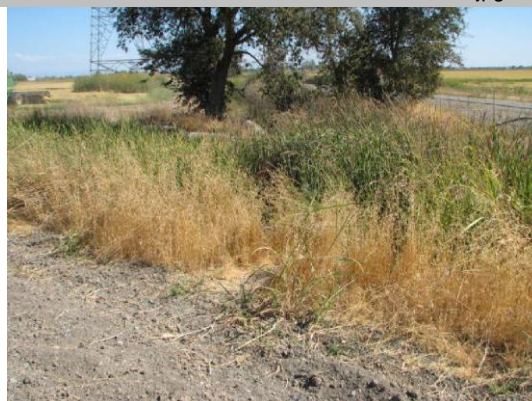
Photo 3 of 3 : UCIP\_FA\_2018\_51500\_64716.jpg

Pipe inlet heavily shielded by vegetation.

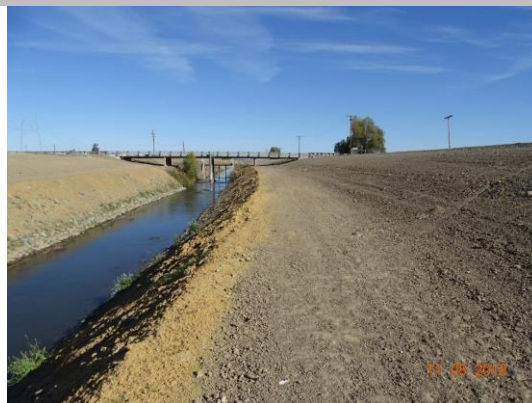
Photo 1 of 1 : FA\_2018\_ST0010\_42\_24\_20181106\_00037.jpg

LM Start	3.25	Rating **	A	Issue No.	24
LM End	3.30	Issue Type +	Ma	Location *	WS
Category	Earthen Levee			GPS Latitude/Longitude	
				Start	End
Item	Erosion / Bank Caving			39.152282 °	39.152925 °
				-121.734580 °	-121.734275 °
DWR ID	DWR_ST0010_01_f_2018_24				
Comment Code					
E1 : Note and monitor erosion site.					
Inspector Comment					
The waterside channel was repaired by Sutter Maintenance Yard.

View of the repaired erosion along the waterside channel.

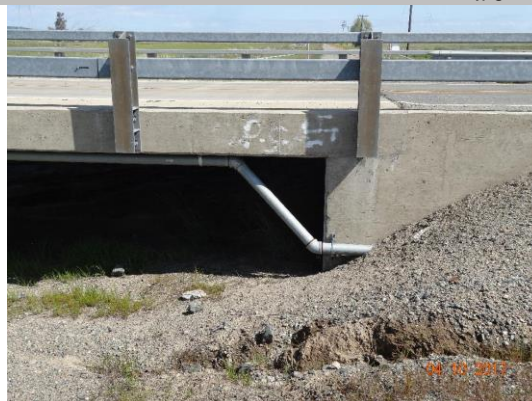
Photo 2 of 3 : UCIP\_FA\_2018\_51501\_76954.jpg

Conduit exiting WS slope and attaching to the downstream side of South Butte Rd bridge.

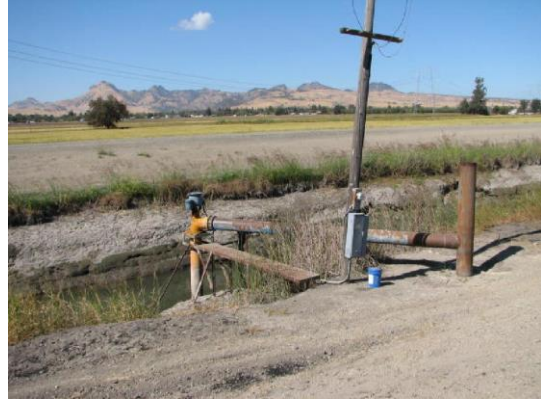
Photo 1 of 3 : UCIP\_FA\_2018\_51502\_64720.jpg

Pump, Pipe, walkway, power pole, and standpipe on WS toe.

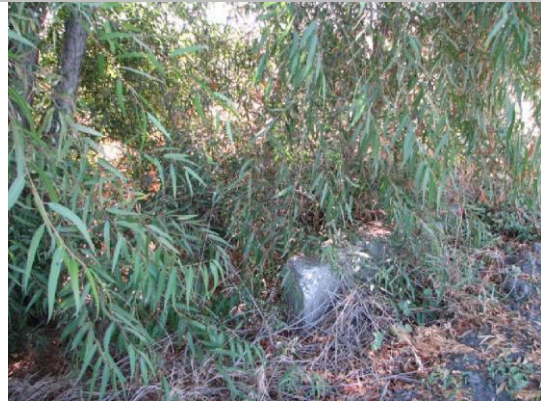
Photo 2 of 3 : UCIP\_FA\_2018\_51502\_64719.jpg

Concrete U shaped headwall on LS toe under tree.

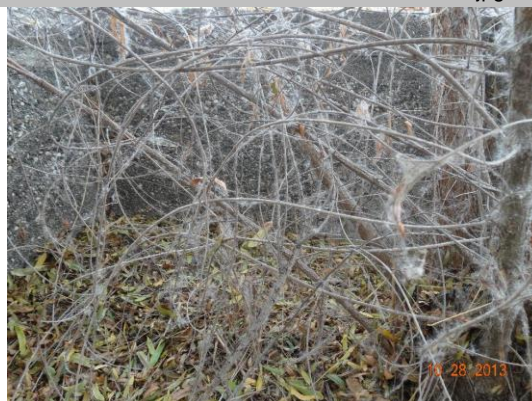
Photo 3 of 3 : UCIP\_FA\_2018\_51502\_64721.jpg

View of LS headwall silted in.

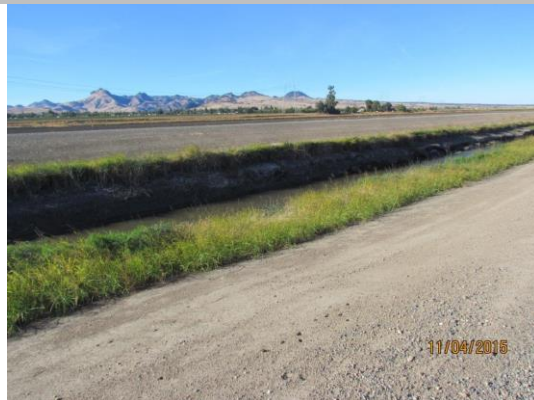
Photo 1 of 1 : FA\_2018\_ST0010\_42\_3\_20180905\_00001.jpg

View of the erosion along the waterside toe.

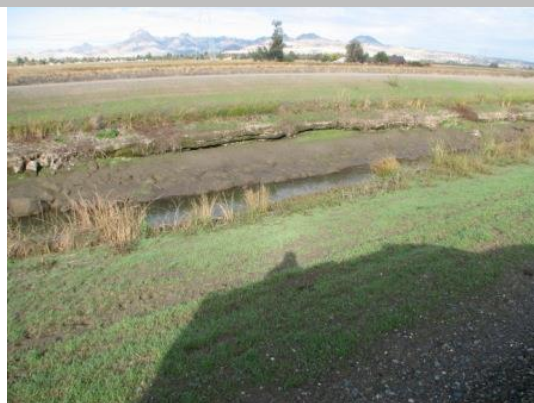
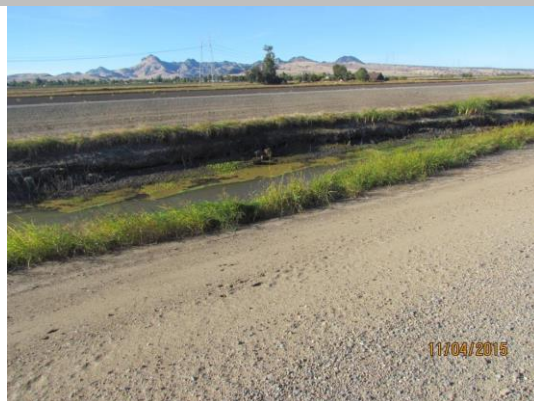
LM Start	3.65	Rating **	A/W	Issue No.	4
LM End	3.65	Issue Type +	Ma	Location *	WS
Category	Earthen Levee			GPS Latitude/Longitude	
				Start	End
Item	Erosion / Bank Caving			39.157861°	39.157861°
				-121.732238°	-121.732238°
DWR ID	DWR_ST0010_01_s_2012_4				
Comment Code					
E1 : Note and monitor erosion site.					
Inspector Comment					
Monitor the erosion along the waterside toe.

View of the erosion along the waterside toe of the levee.

View of the erosion along the waterside toe.

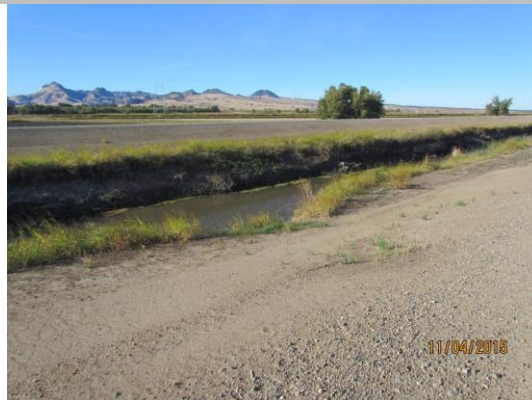
Photo 1 of 1 : FA\_2018\_ST0010\_42\_17\_20180905\_00010.jpg

View of the erosion along the waterside toe.

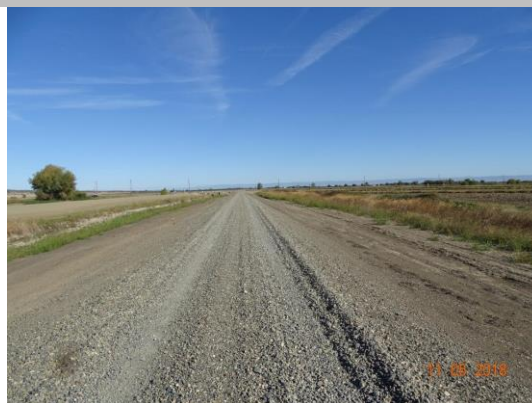
Photo 1 of 1 : FA\_2018\_ST0010\_42\_21\_20181106\_00036.jpg

View of no vegetation on both slopes.

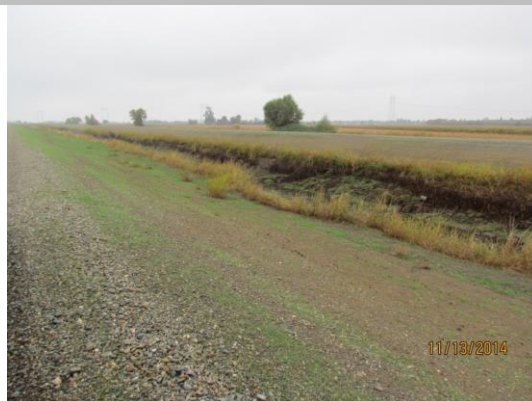
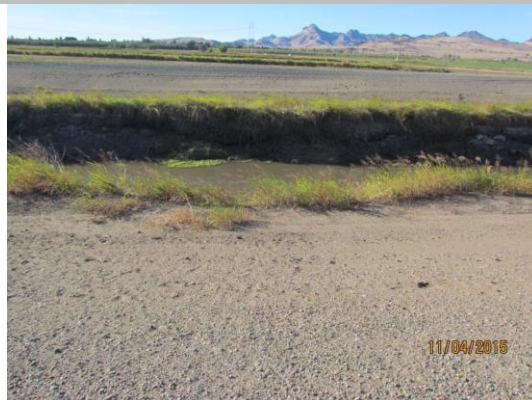
View of the erosion along the waterside toe.

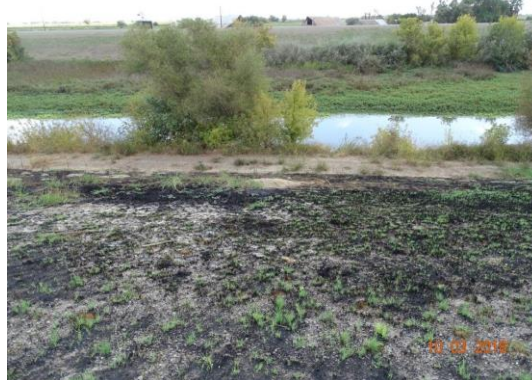
Photo 1 of 1 : FA\_2018\_ST0010\_43\_17\_20181008\_00035.jpg

LM Start	0.24	Rating **	M	Issue No.	17
LM End	0.24	Issue Type +	Ma	Location *	WS
Category	Earthen Levee			GPS Latitude/Longitude	
				Start	End
Item	Animal Control			39.116913 °	39.116913 °
				-121.766768 °	-121.766768 °
DWR ID	DWR_ST0010_02_f_2018_17				
Comment Code					
A3 : No rodents visible, but rodent burrows visible; need to backfill and compact or grout burrows.					
Inspector Comment					
Repair the rodent hole along the waterside slope.

View of the rodent hole along the waterside slope.

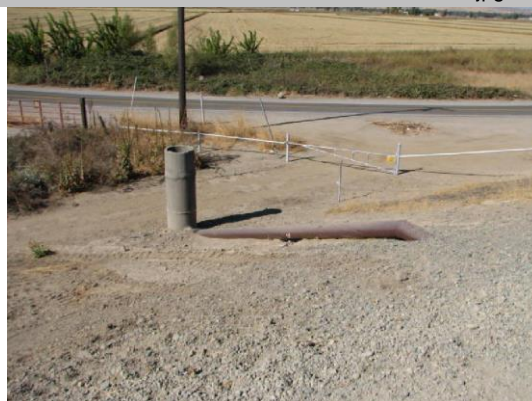
Photo 1 of 3 : UCIP\_FA\_2018\_51506\_64728.jpg

Pipe and Standpipe on LS toe.

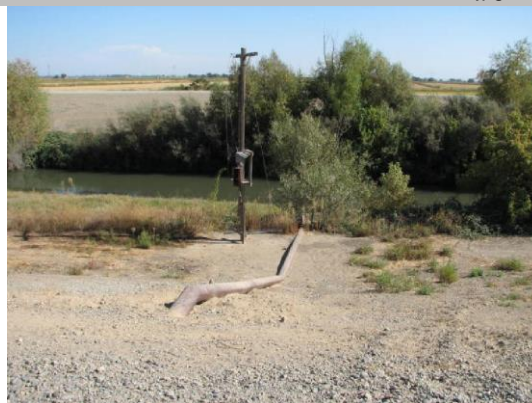
Photo 2 of 3 : UCIP\_FA\_2018\_51506\_64727.jpg

Pipe and pump facilities on WS slope.

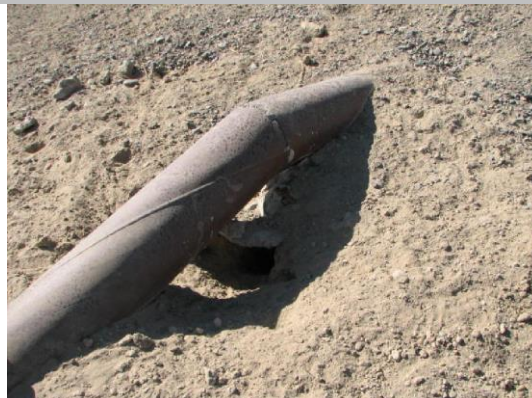
Photo 3 of 3 : UCIP\_FA\_2018\_51506\_64726.jpg

Heavy rodent activity along pipe, both sides.

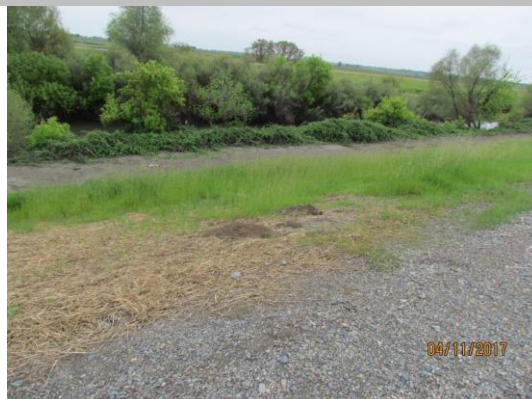
Photo 1 of 1 : FA\_2018\_ST0010\_43\_19\_20180905\_00013.jpg

LM Start	1.16	Rating **	U	Issue No.	19
LM End	1.16	Issue Type +	Ma	Location *	WS
Category	Earthen Levee			GPS Latitude/Longitude	
				Start	End
Item	Animal Control			39.127527 °	39.127527 °
				-121.756493 °	-121.756493 °
DWR ID	DWR_ST0010_02_f_2016_19				
Comment Code					
A3 : No rodents visible, but rodent burrows visible; need to backfill and compact or grout burrows.					
Inspector Comment					
Repair the rodent holes along the waterside slope.

View of the rodent holes along the waterside slope.

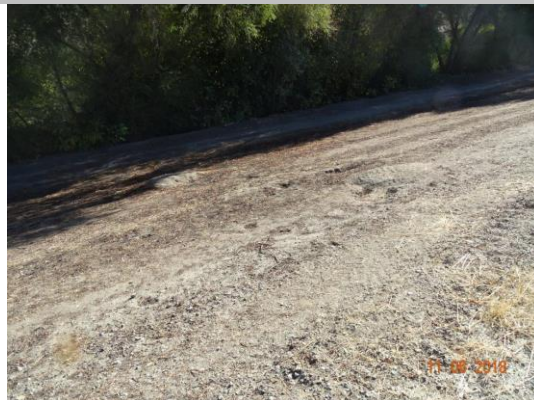
Photo 1 of 1 : FA\_2018\_ST0010\_43\_23\_20181106\_00040.jpg

LM Start	1.71	Rating **	M	Issue No.	23
LM End	1.71	Issue Type +	Ma	Location *	WS
Category	Earthen Levee			GPS Latitude/Longitude	
				Start	End
Item	Animal Control			39.133912 °	39.133912 °
				-121.750258 °	-121.750258 °
DWR ID	DWR_ST0010_02_f_2018_23				
Comment Code					
A3 : No rodents visible, but rodent burrows visible; need to backfill and compact or grout burrows.					
Inspector Comment					
Repair the rodent holes along the waterside slope.

View of the rodent holes along the waterside slope.

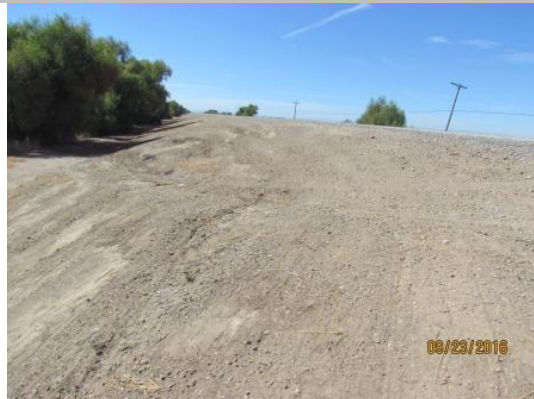
Photo 1 of 1 : FA\_2018\_ST0010\_43\_20\_20180905\_00014.jpg

View of the ramp encroaching into the levee.

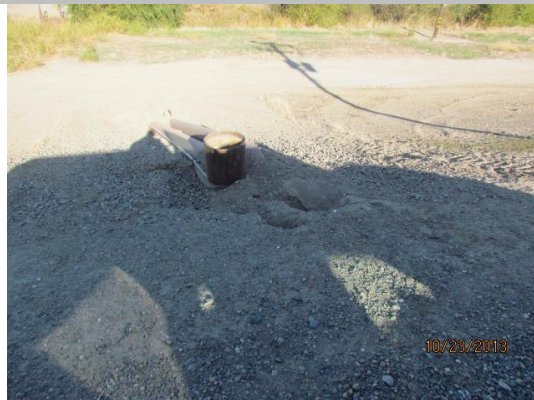
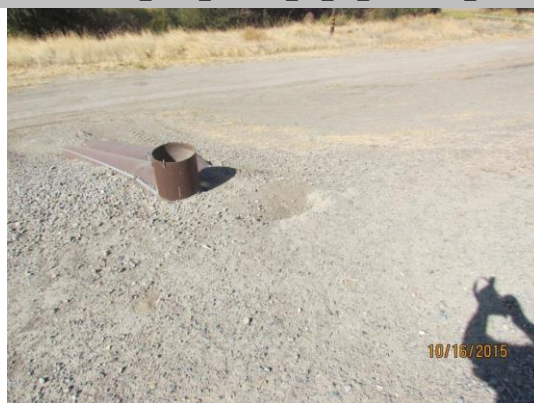
View of the rodent holes above the irrigation pipe.

View of the rodent hole above the irrigation pipe.

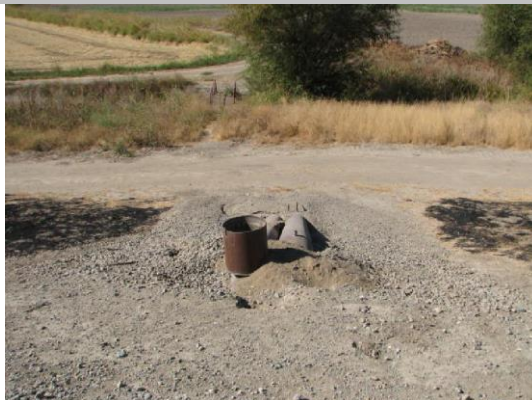
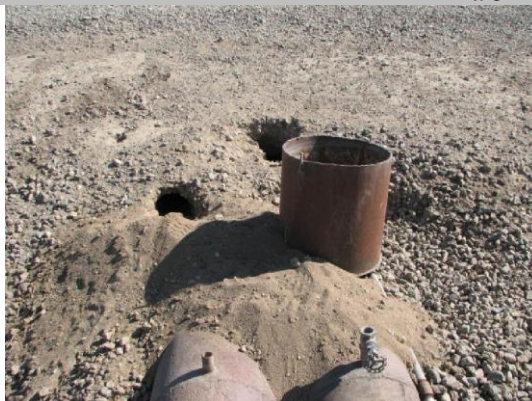
Pipe on LS showing rodent activity.

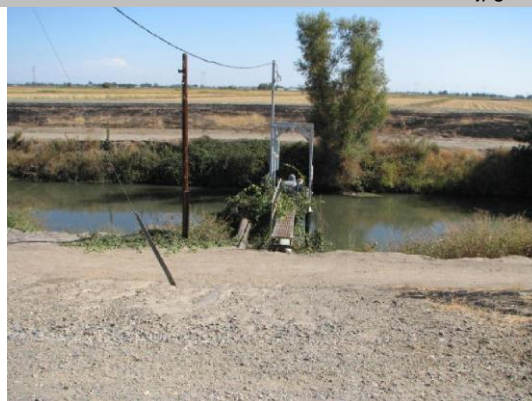
Photo 3 of 3 : UCIP\_FA\_2018\_51512\_64734.jpg

Pipe on left without pump.

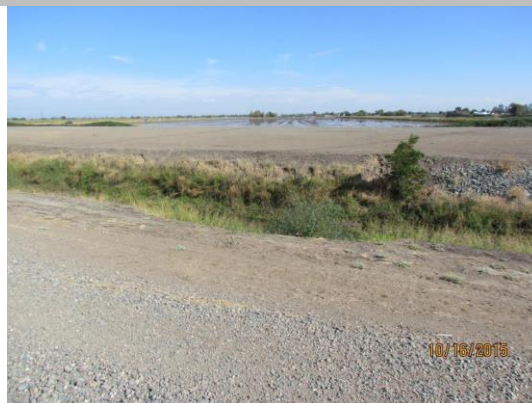
Photo 1 of 2 : FA\_2018\_ST0010\_43\_8\_20180905\_00007.jpg

View of erosion along the waterside toe.

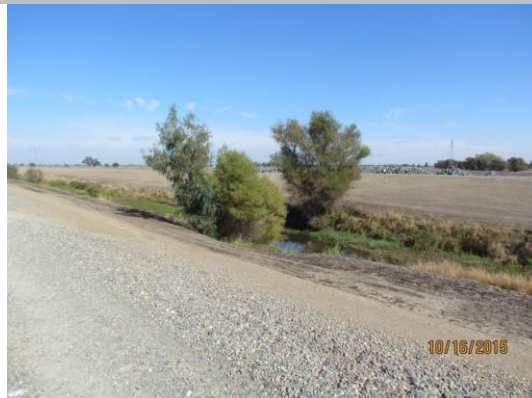
Photo 2 of 2 : FA\_2018\_ST0010\_43\_8\_20180905\_00008.jpg

View of the erosion along the landside toe.

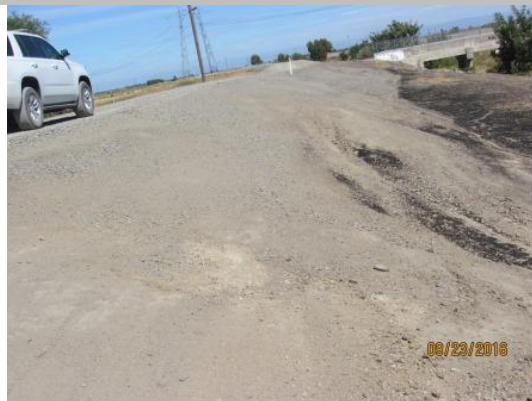
Photo 1 of 1 : FA\_2018\_ST0010\_43\_21\_20180905\_00015.jpg

View of the ramp encroaching into the levee.

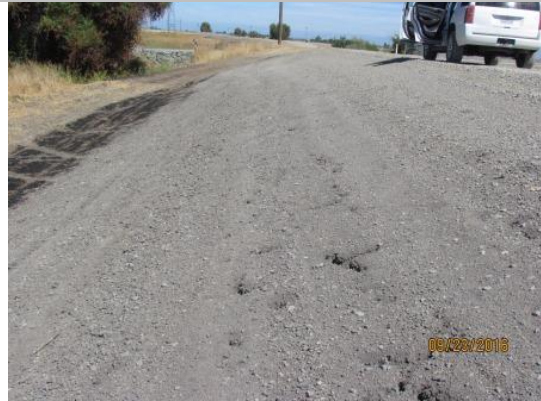
Photo 2 of 2 : FA\_2018\_ST0010\_43\_22\_20180905\_00017.jpg

View of the longitudinal cracks along the landside slope.

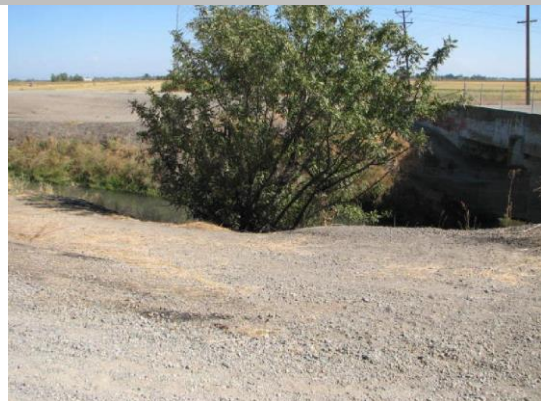
Photo 1 of 3 : UCIP\_FA\_2018\_51515\_64744.jpg

Bush camouflaging outlet of pipe on WS slope.

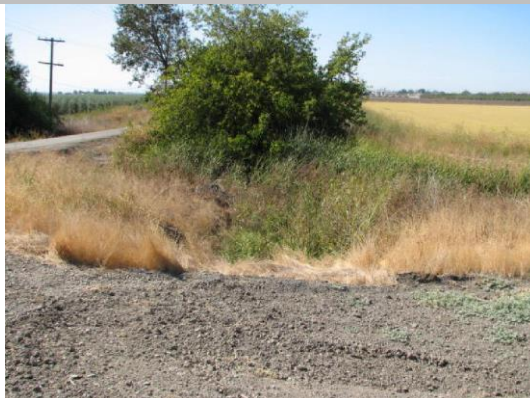
Photo 2 of 3 : UCIP\_FA\_2018\_51515\_64743.jpg

Heavy vegetation at LS inlet at channel.

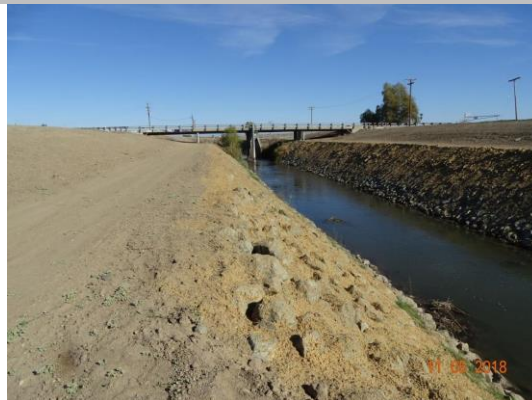
Photo 1 of 1 : FA\_2018\_ST0010\_43\_18\_20181106\_00036.jpg

View of the repaired erosion along the waterside channel.

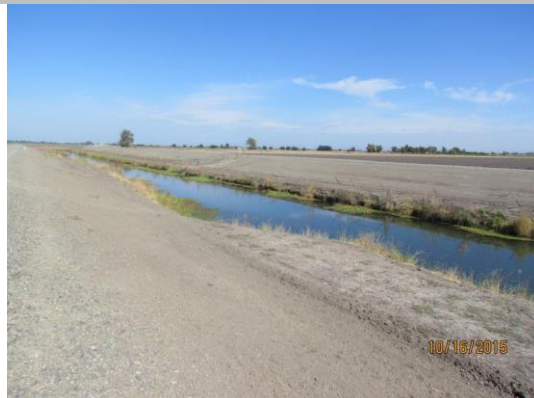
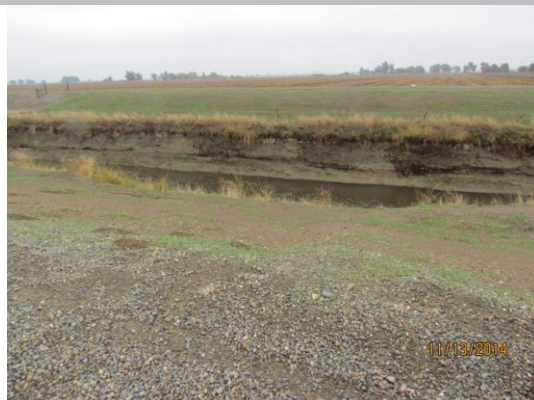
View of the erosion along the waterside toe.

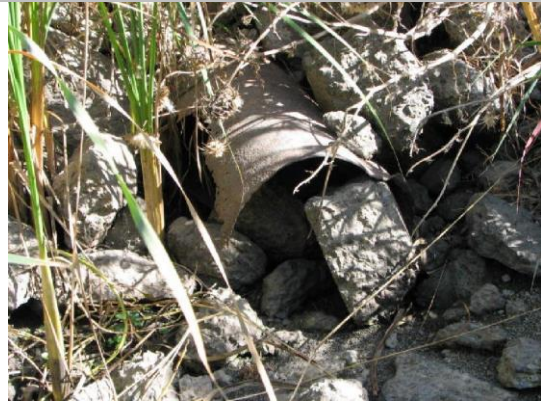
Photo 2 of 3 : UCIP\_FA\_2018\_53066\_64760.jpg

Rusted outlet at LS channel. Unclear if this is same pipe as one under investigation.

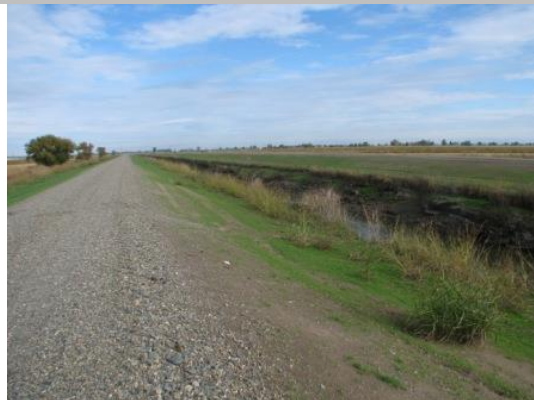
Photo 2 of 2 : FA\_2018\_ST0010\_43\_5\_20180905\_00003.jpg

View of the erosion along the waterside toe.

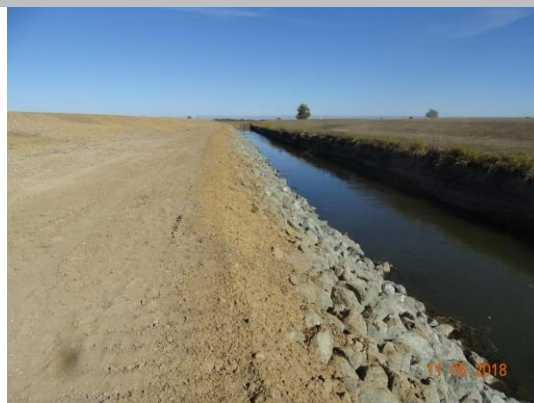
Photo 1 of 2 : FA\_2018\_ST0010\_43\_7\_20181106\_00039.jpg

View of the repaired erosion along the waterside channel.

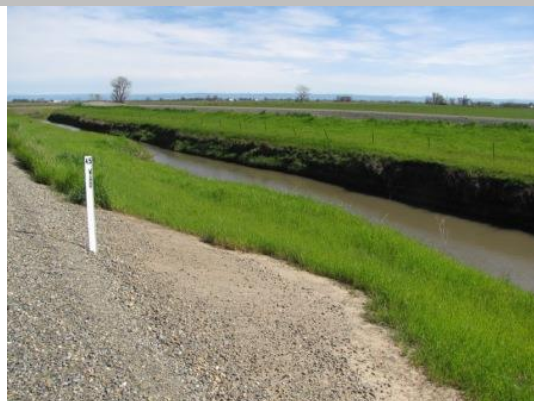
Photo 2 of 2 : FA\_2018\_ST0010\_43\_7\_20180905\_00005.jpg

View of the erosion along the WS toe.
